INTERPACK 99

Failure Engineering Study and Accelerated Stress Test Results for the Mars Global Surveyor Spacecraft's Power Shunt Assemblies

Mark Gibbel, Tim Larson

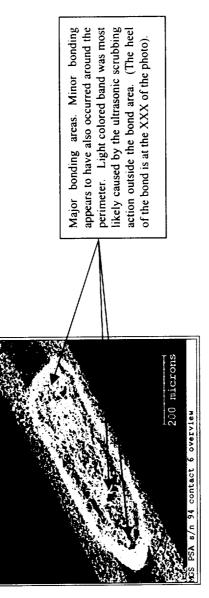
CLOSE UP OF A TYPICAL FAILURE SITE

Figure 8. View of bond pad #6 in S/N 094 showing area where bonding occurred.

- ALL SIGNIFICANTLY DEGRADED
- TWO HAD NO PULL STRENGTH
- MANY LESS THAN 20% LIFE REMAINING (LAST 20 % GOES VERY FAST)

- VIRGIN WIREBONDS FAILED MOSTLY IN THE HEEL ON THE DIE SIDE
- STRESSED WIREBONDS MOSTLY FAILED IN THE BOND METAL ON THE DIE SIDE
- POWER +THERMALLY VS. JUST THERMAL FAILURE RESULTS ABOUT SAME FOR CYCLED
- SMALL % OF CAPABILITY USED

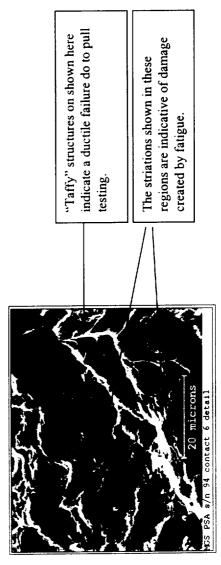
Figure 9. Close up of region shown by middle arrow in Figure XXX.
